Lessons from the accident at the Sayano-Shuskenaya hydropower station

Bryan Leyland MSc, FIEE, FIMechE, FIPENZ.

EEA Conference & Exhibition 2010, 17-18 June 2010, Christchurch

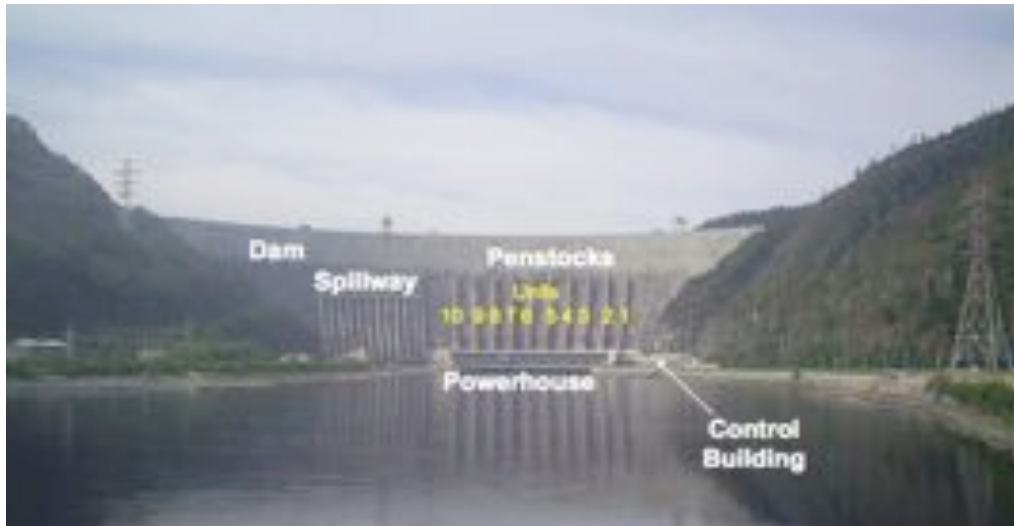
Figure 1 Dam and 6400 MW power station

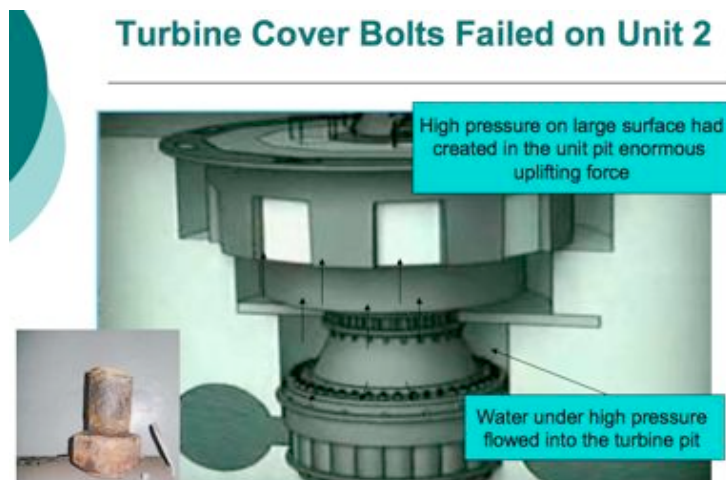
The high vibration induced fatigue cracking in the turbine cover bolts. In the final moments they broke off in sequence until they could no longer contain the pressure under the turbine cover. At this point, the remaining bolts broke simultaneously. The water pressure beneath the turbine was sufficient to hurl the turbine cover - which carried the generator thrust and guide bearings - and the generator rotor into the air. The turbine cover was a reasonably neat fit in the turbine pit and, in effect, the turbine pit became the cylinder of a huge hydraulic ram

Figure 2 Turbine and generator assembly

and the whole area of the turbine cover became the piston.

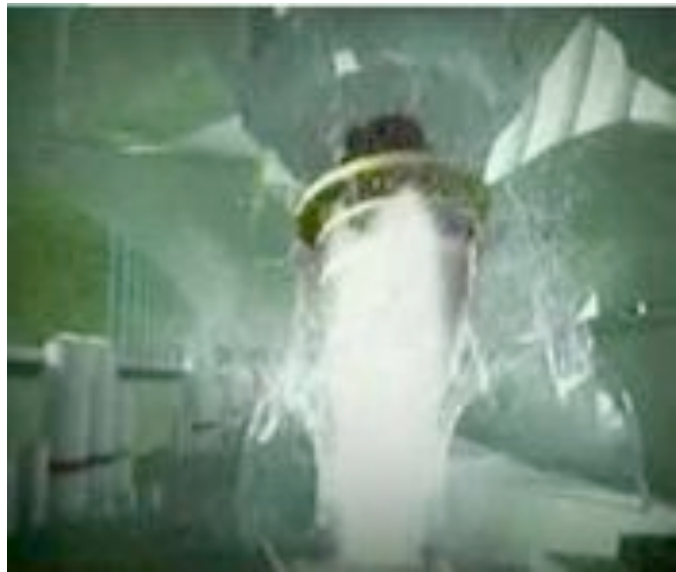
Sufficient force was generated to hurl the still rotating turbine and generator rotor something like 14 m into the air. The total weight was in excess of 1500 tonnes. Because of the gyroscopic effect, the spinning mass descended back into the turbine generator pit. The rotor then disintegrated and the remains of the rotor spider became wrapped around the generator shaft.

Figure 3 Unit 2 Generator rotor and turbine spinning above the generator floor level

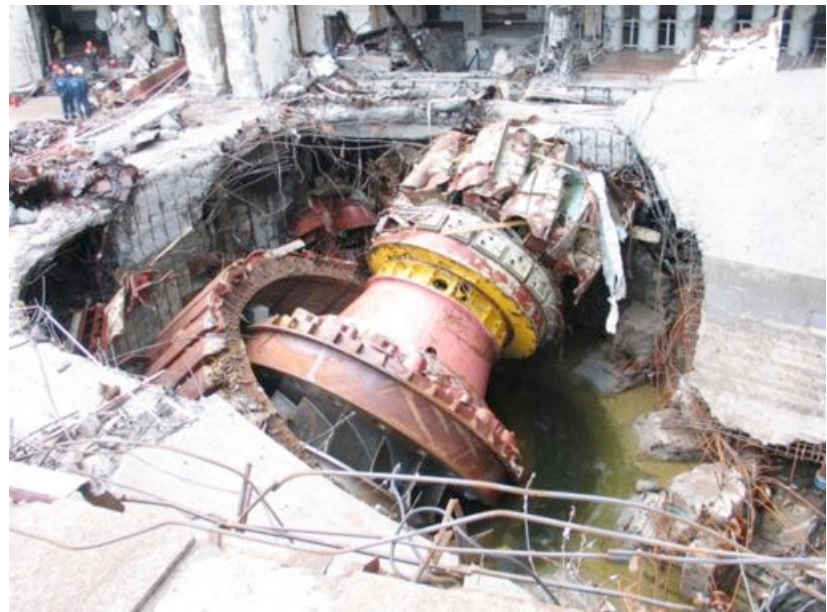
Figure 4 Unit 2 turbine and rotor spider

The probable cause of the failure was excessive vibration causing long term fatigue of the bolts holding the turbine cover to the stayring. According to the 3rd October report, many of the bolts had major fatigue cracks. Some, it seems, had their nuts missing completely. Inspection of the bolts after the accident revealed that several of them had cracked right through from long-term metal fatigue at some time before the accident.
